Sample Report

0000 Penny Lane

Inspection Date: 04/03/2009

Report Number: AA040309

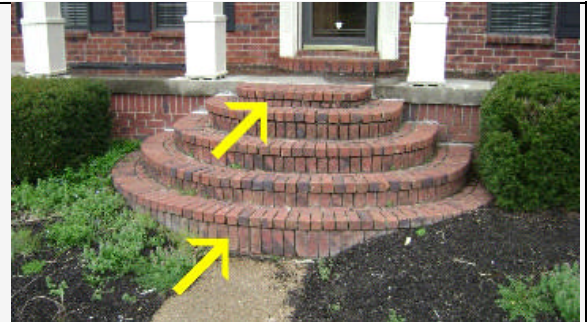
The front entry stoop steps are not uniform in height. Steps are required to be uniform in depth and each step uniform in height in any stairway between two floors. There should be no variation exceeding 3/8" in the depth of the adjacent step and no more than 3/8" difference in step height. This can cause a tripping situation. Safety Issue.

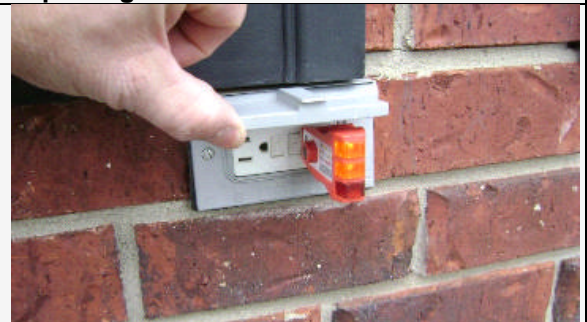
The GFCI front entry stoop outlet is either defective or incorrectly wired and needs corrected. It did not function properly when tested during the inspection. Safety Issue.

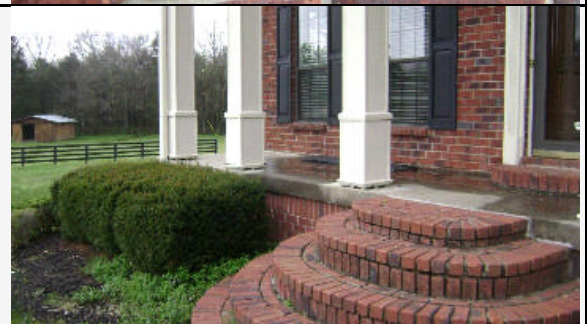
Entry Stoop Handrail

No handrail was present on the entry stoop at the time of the inspection. Though the structure predates the standard handrail requirements, any stairway or entry stoop over 4 steps or 30" in height should have a handrail. One should be considered for safety related issue.

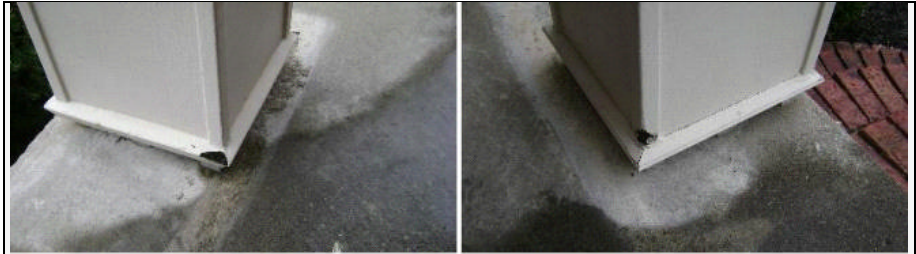
Entry Stoop Post

The lower sections of the front porch post show signs of decay and need repaired before further deterioration occurs.

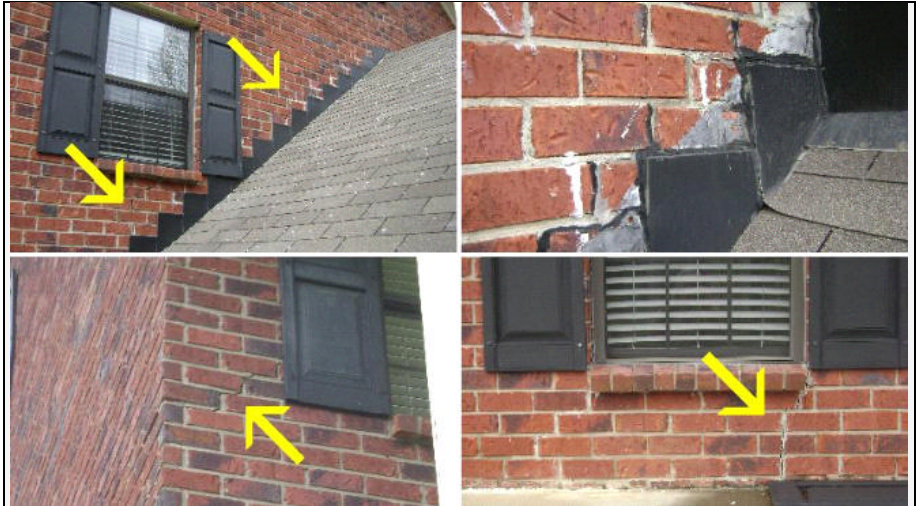
Cracks of 1/4" and wider were noted in the brick veneer in these areas; over the garage roof, under the upper and lower window on the left front entry stoop, over the left end roof on the back side of the fireplace, and on the right end of the detached garage. This may be an indication of settlement or movement in the foundation. This condition warrants further investigation and analysis by a professional structural engineer and/or a licensed qualified foundation contractor to determine the cause and course of action.

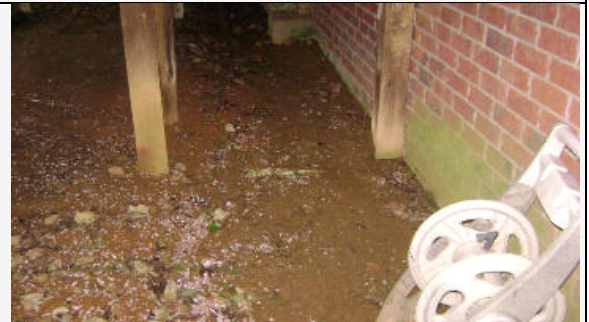
The drainage around the structure should slope away from the foundation at a rate of 1/2 inch per foot for 6 feet. Portions of the ground under the rear patio deck do not meet this minimum standard. Grading should be altered or underground drainage installed in order to lead water away from the foundation of the house.

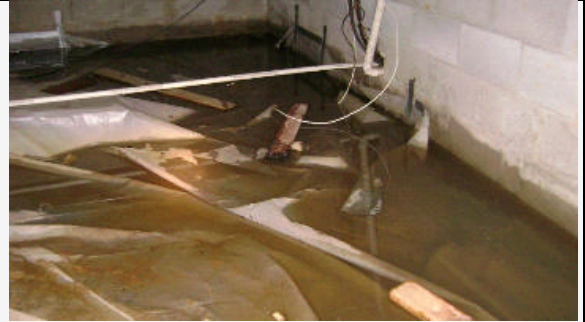
Water was found standing on the lower end of the crawlspace floor. The gutters should be kept clean, the downspouts extended from the foundation at least 4 to 6 feet, and the ground properly sloped to channel the rain water away from the structure. The sump pump found in the crawlspace should also be relocated to the lowest portion of the crawlspace floor to help remove this water.

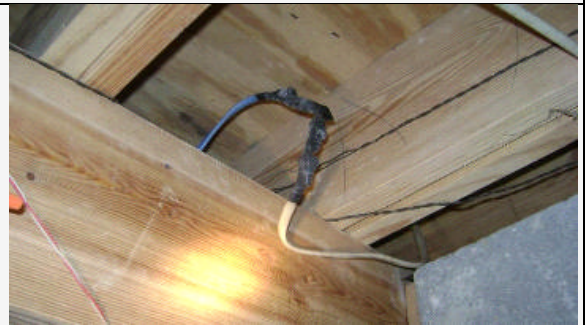
One or more electrical splices were found under the house in the crawlspace that are not properly spliced in an approved electrical junction box. This should be corrected by a qualified license electrician. Safety issue.

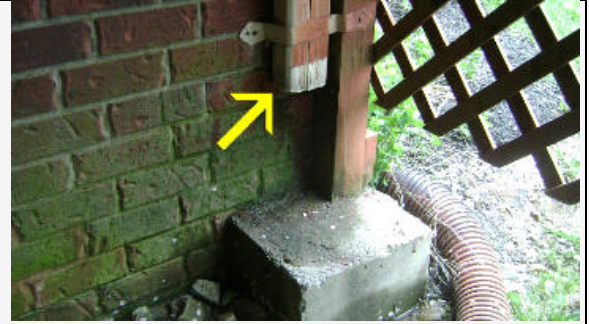
The inspector recommends extending the gutter downspouts on all sides of the house to safely exit the unwanted rain water away from the house's foundation and to help prevent moisture from entering the crawlspace or basement below.

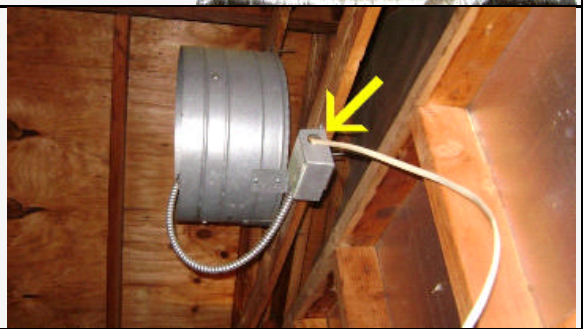
Electrical Condition	<p>The wire feeding the attic fan is not properly connected to the housing of the fixture. An electrical connector or bushing should be installed to protect the wire from the sharp metal edge of the housing.</p>

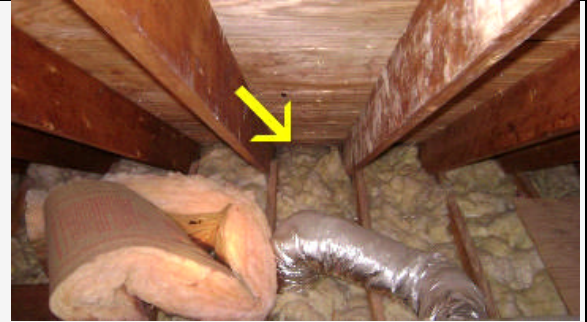
Insulation was found in the attic in contact with the roof's sheathing. There should be at least a 1 1/2" air gap between the insulation and the roof sheathing. This contact will lead to condensation in the attic and limits airflow for proper attic ventilation. Either the insulation should be repositioned or styrofoam baffles that are designed for this type of application be installed. This limited airflow will also decrease the life of the roofing shingles.

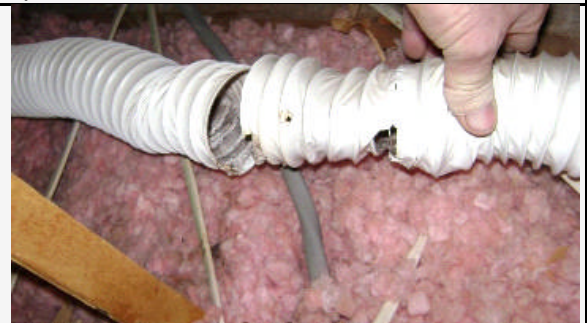
The bathroom exhaust fan(s) duct was found damaged or leaking into the attic area. This introduces excess moisture into the attic. The inspector recommends installing new flexible ducts that exit at the soffit or gable vent or even better through the exterior wall.

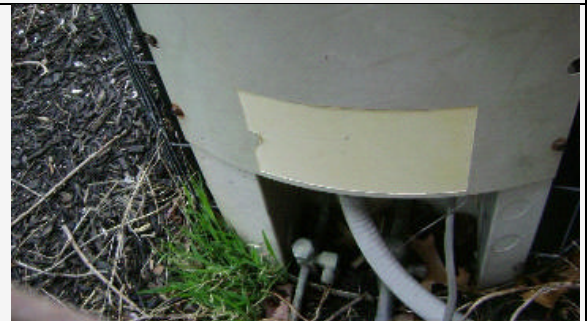
The model plate on the air conditioner/heat unit has completely faded making it impossible to identify any pertinent information to help aid in fully inspecting the unit.

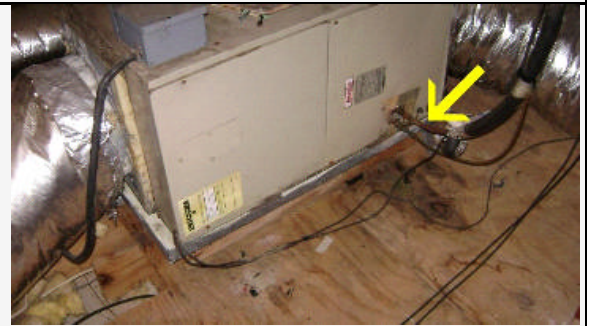
The insulation wrap on the suction line to the HVAC air handler in the attic is in need of attention due to deteriorated or missing insulation. The piping should be fully insulated and sealed to prevent condensation from forming and dripping on the attic floor and the ceiling below. This will also effect the efficiency of the cooling system.

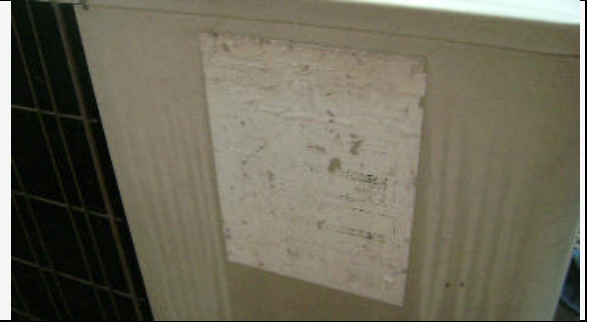
The model plate on the air conditioner/heat unit has completely faded out making it impossible to identify any pertinent information to help aid in fully inspecting the unit.

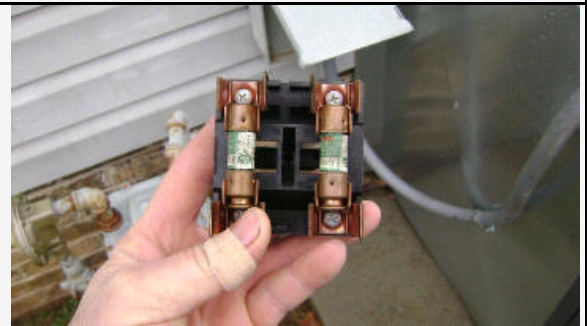
The electrical fuses for the outside HVAC unit are oversized per the recommended fuse size of the mfg. stated on the model number plate. The mfg recommends a maximum fuse size of 20 amps and the fuses currently installed are 30 amps. This condition could severely damage the unit if it were to become overloaded. Repairs are needed.

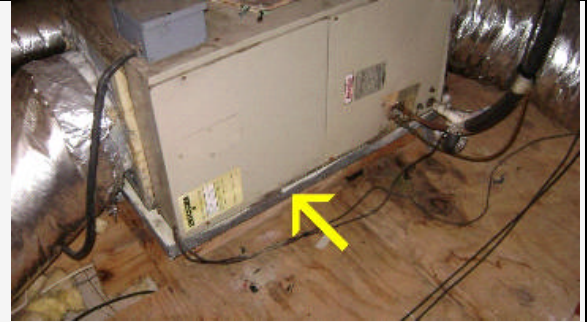
There is a secondary drain pan present under the HVAC air handler in the attic, however, the required drain line or float switch was not found installed. This should be corrected to help protect the attic floor and ceiling below from possible water damage.

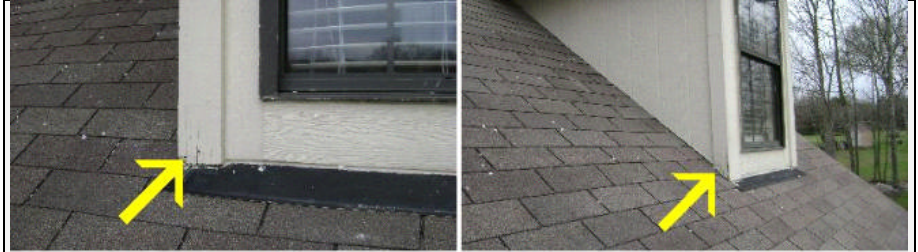
Wood decay was found on both lower sections of trim on the front dormers over the attached garage. This will need replaced.

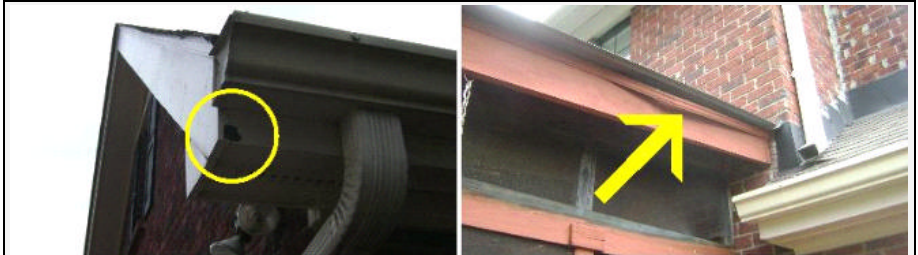
The fascia and/or rake boards on sections of the house show signs of deterioration. Certain areas may need replaced while others will only need caulked and repainted. (2) The rake board trim over the screen porch needs some additional nailing to better secure it to the structure.

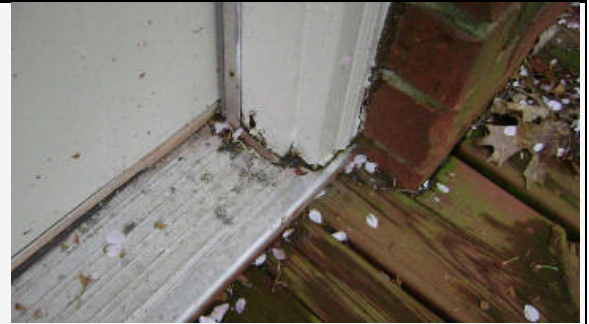
The lower jamb of the rear french exterior doors have been penetrated with water showing signs of wood decay and if not stopped will continue to deteriorate. The inspector recommends making the necessary repairs and installing a storm door or overhead awning to help protect and prevent further damage.

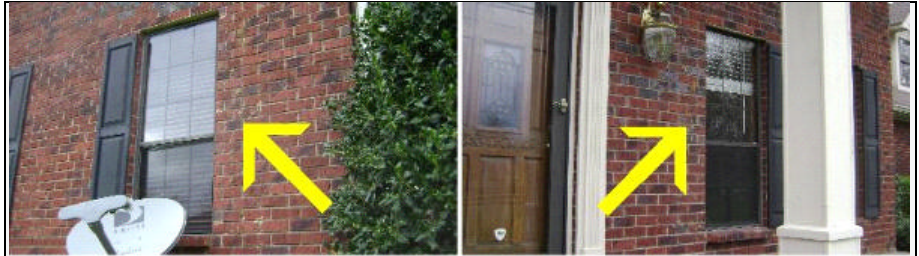
One or more window shutters were either damaged or found missing.
Replace or repair as needed.

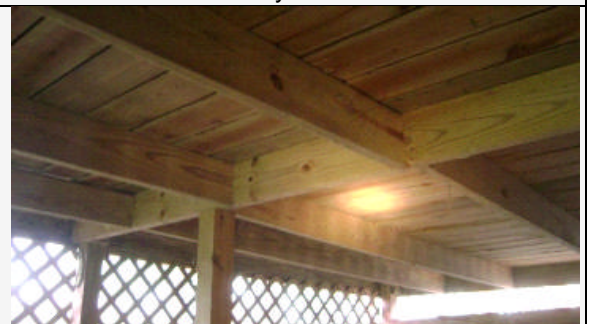
The patio deck framing does not meet today's minimum safety standards. The floor joist are not supported by either joist hangers or ledger strips and the joist width and span appear insufficient. The inspector recommends having the deck inspected and any necessary repairs made by a qualified license decking contractor. This is

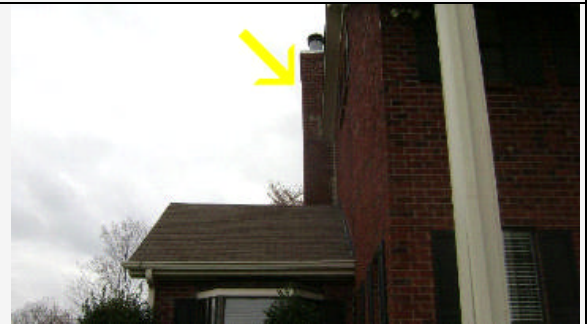
The chimney stack appears has pulled away from the main structure and appears unlevel. This should be inspected by a structural engineer or foundation contractor and the necessary repairs made to stabilize the chimney stack.

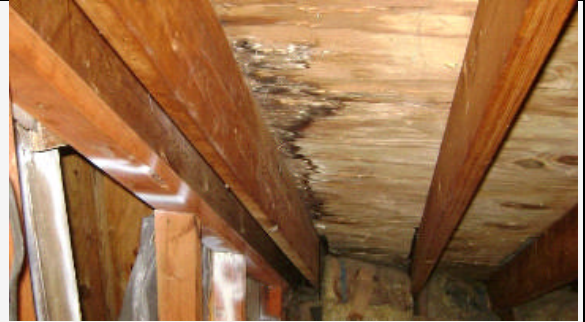
Water stains were found on the underside of the roof sheathing in the attic under the fireplace flashing. No elevated moisture levels were measured and the stains appear to have come from a prior leak. The area should still be monitored however during heavy rain and the necessary repairs made if one re-occurs.

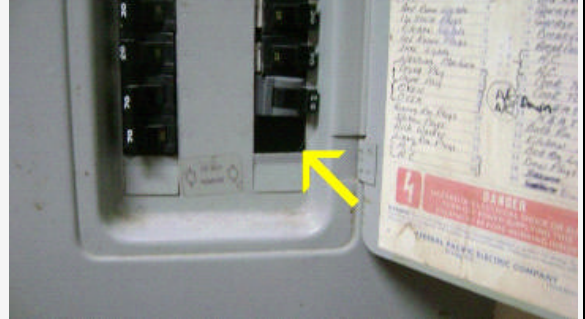
Missing knock-out plates were found on the front of the panel enclosure. These should be installed to prevent electrical connections from being exposed. Safety Issue.

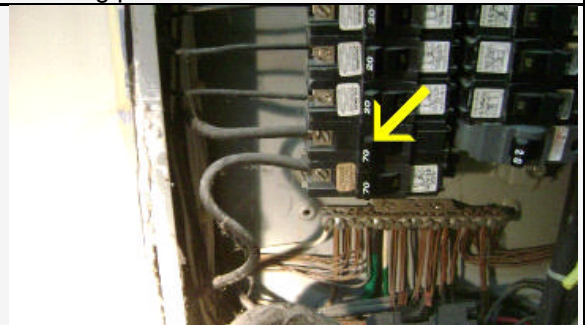
One or more breakers/fuses were found in the main power panel that are not appropriately matched with the correct wire gauge size. An overdraw condition could cause melting, insulation overheating, or fire. IMMEDIATE ACTION IS REQUIRED. Repairs should be performed by a qualified licensed electrician.

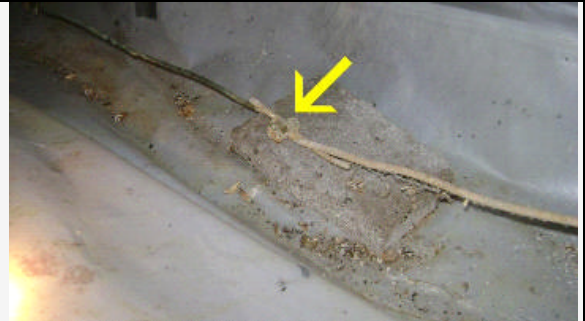
The main service ground has been spliced under the house in the crawlspace. Splices are not allow in any section of the grounding conductor. This should be corrected by a qualified license electrician. Safety Issue.

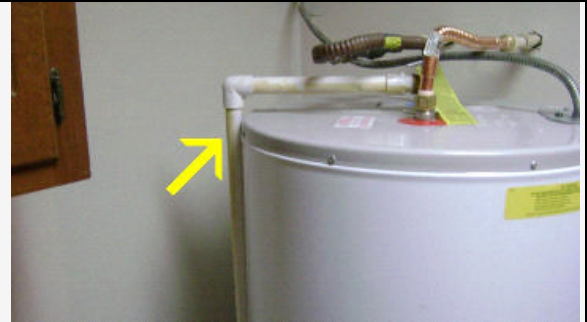
There is an overflow pipe installed on the water heater however it does not extend to within 6" of the floor. The existing pipe should be replaced with a pipe that can withstand 200 degrees F. and be 3/4" in diameter. Safety Issue, PVC pipe material was found on the TRP valve and is not allowed to be installed as an overflow or discharge pipe for the water heater. The temperature rating for the pipe material is only 73 degrees and the water at the discharge could be 210 degrees at over 150 PSI. It is recommended that this pipe be replaced with a copper pipe or CPVC pipe. The pipe should extend to within 4 inches of the floor. If plastic, it should be supported with non-abrasive straps at 3' intervals.

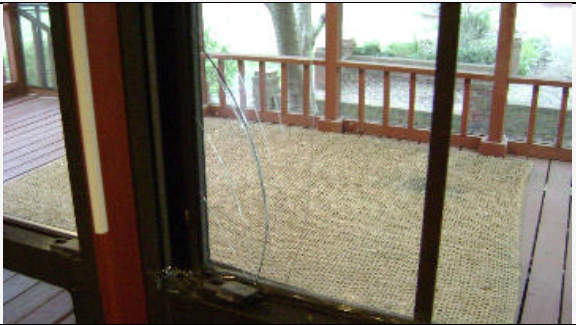
Location:	Main level rear of house.
Exterior Door:	The exterior entry door to the kitchen appears to be in satisfactory condition.
Entry Door:	The entry door(s) to the kitchen appear satisfactory.
Windows:	<p>At least one window or associated hardware in the kitchen needs repair or replacement. A broken window pane was found in the dinette area.</p>

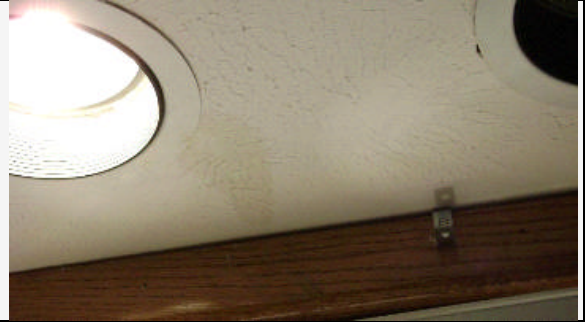
Leak stains were found in the ceiling of this room around the light over the kitchen sink. Action is necessary to determine if the leak has been successfully repaired.

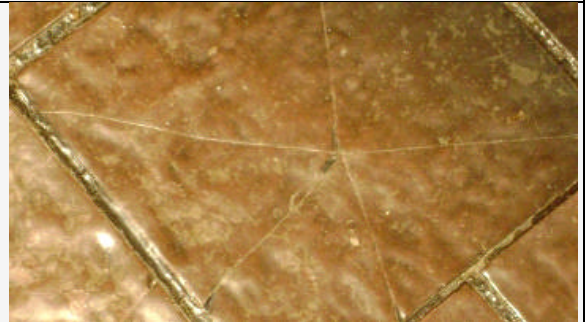
Several hairline cracks were found in the tile floor of the kitchen. There was no evidence of movement in the subfloor and it was undetermined the cause of the cracks.

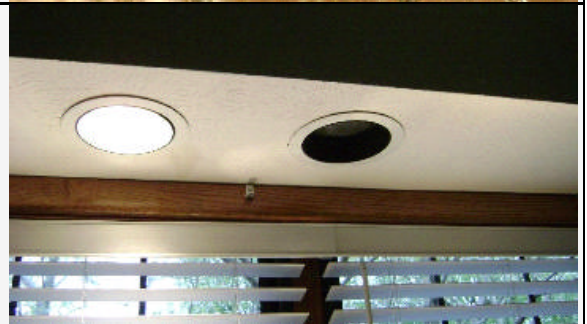
One or more lights in the kitchen did not function during the inspection when tested. The light bulb(s) are believed to be burned out, however, this cannot be verified without replacing the bulbs. The dimmer switch that controls the dinette light needs to be replaced with a 3-way dimmer switch instead of the current 2-way. The light cannot be properly operated from the switch located by the back door.

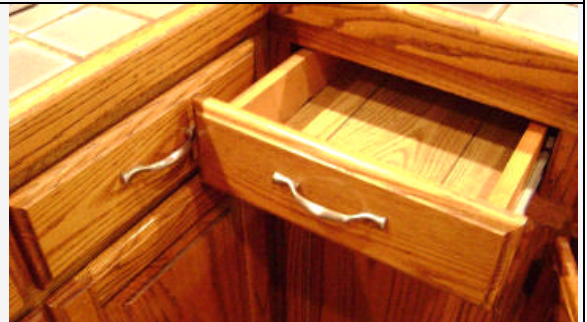
The cabinets, doors, and drawers appear in satisfactory condition. However the drawers left of the sink interfere with each other when opening.

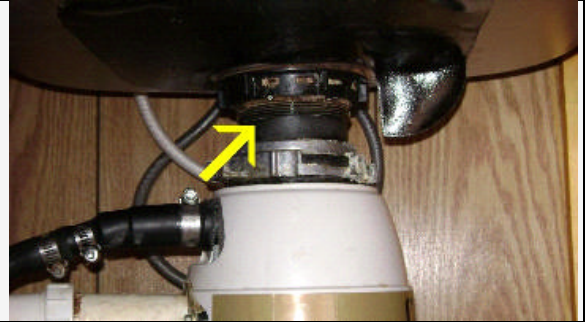
The garbage disposal was found leaking where it attaches to the kitchen sink. Repairs are necessary.

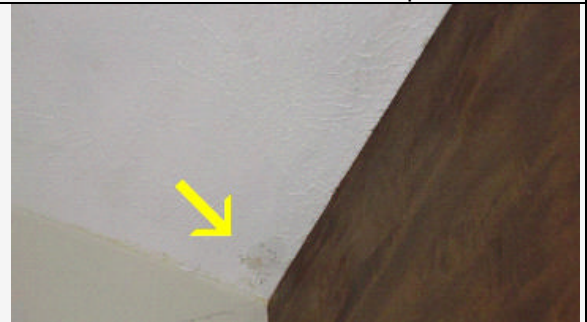
Leak stains were found on the ceiling of this room. Due to the condition of the roof and no active leaks in the attic, these stains are believed to be from a prior leak. The stains should be painted and the area monitored for any future leakage. These are located on the ceiling by the laundry

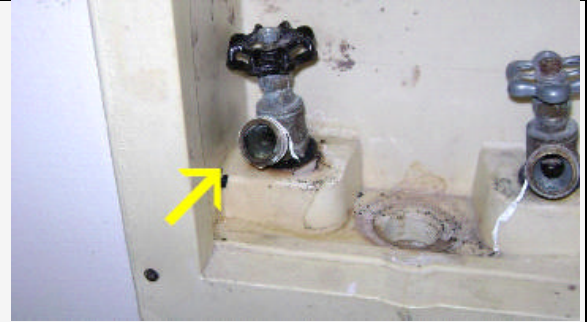
There is a connection box installed in the wall with both hot and cold water and a drain pipe. The drain pipe was not flood tested. The hot water faucet was found leaking during the inspection however it will not be an issue when the washing machine hose is connected.

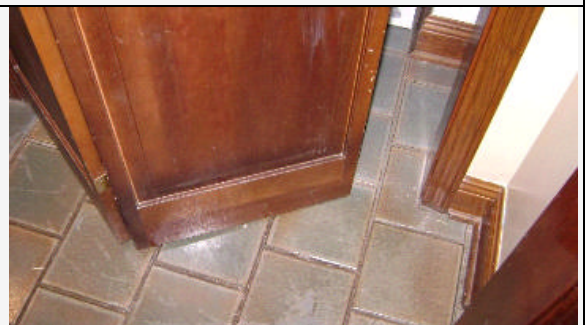
The bi-fold hallway closet doors are interfering with the floor when opened. Some adjustments or trimming is needed.

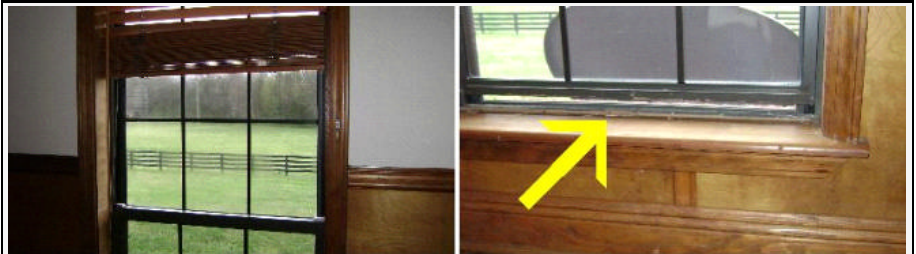
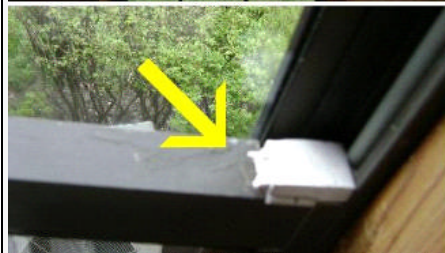
At least one window or associated hardware in this room needs repair or replacement. The thermal seal between the two panes of glass appear broken. Although the window is keeping the elements out, it has a clouded or wet like appearance. This condition will worsen and the panes will eventually need replaced. The assist spring or window track that supports the window in the up position is not functional. Repairs are needed. The broken assist spring was on the right side window. Also several of the plastic window release levers were found broken.

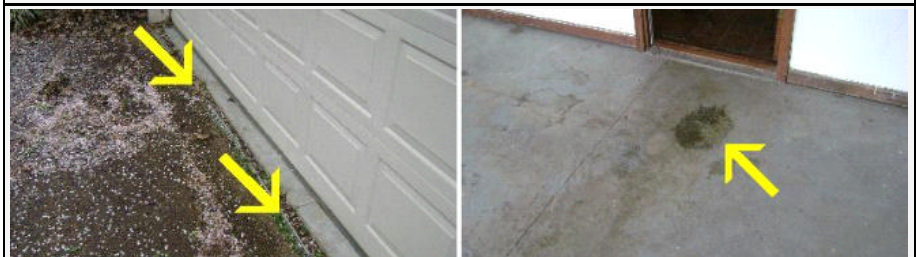
The french drain outside the garage door is full of debris and in need of attention. Moisture stains and water were present on the garage floor during the inspection. Cleaning and possible repairs to the drain are needed.
