Sample Report

0000 Penny Lane

Inspection Date: 04/03/2009

Report Number: AA040309

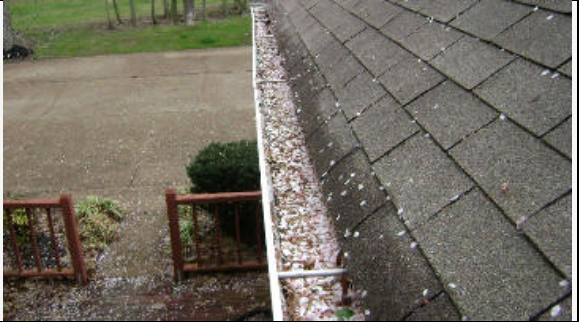
Estimated Life Expectancy of Roof:	The roof covering material appears to have a remaining life expectancy of 5 to 8 years, assuming proper maintenance is completed as needed.
Slope:	High slope is considered to be 7 in 12, or higher.
Flashing:	The flashings around openings in the roof covering appear to be watertight and caulked as needed.
Plumbing Vent Pipe Boot	The rubber vent pipe flashing appears in satisfactory condition. They should be inspected annually for splits or cracks and replaced when they are present to prevent a leak.
Means of Roof Inspection:	The roof was inspected by the roof's edge on some portions of the structure and binoculars were also used to view the roof covering on the higher levels.
Ridges:	The ridge covering material appears to be in satisfactory condition.
Evidence of Leakage:	No -
Roof Gutter System:	<p>The gutter system is filled with debris in some areas which will interfere with channeling the rain water away from the structure. They should be cleaned annually and gutter screens are recommended.</p>

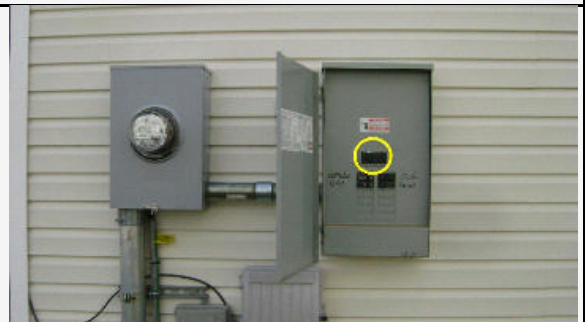
Main Power Disconnect

Located on the exterior wall by the meter base. This is important to know in case of an emergency.

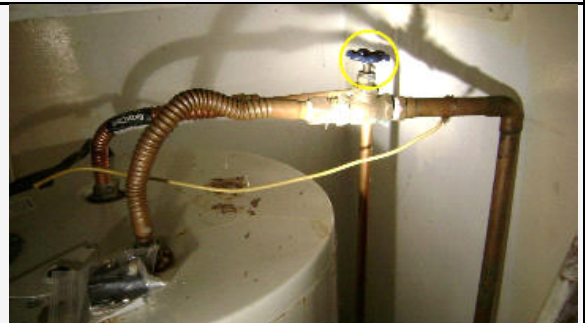
Main Water Line Cutoff Location:

Located behind or above the water heater. This is important to know in case of an emergency.

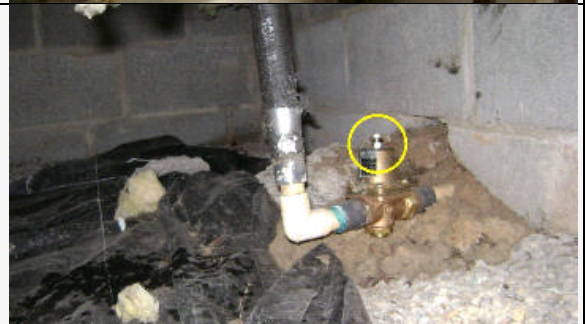
Water Pressure Regulator Valve Present:

Yes. The regulator is located in the crawlspace on the front side of the house where the main water line enters the house.

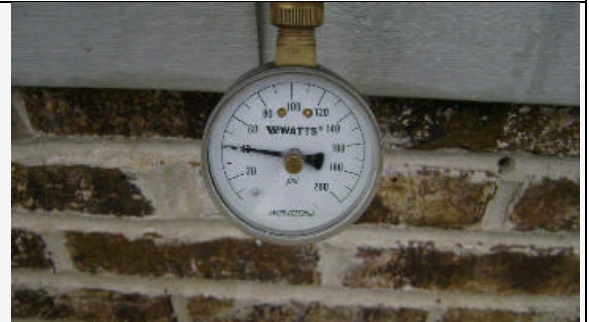
Water Pressure:

Water pressure was measure at either one of the exterior hose bibs or at the laundry room washing machine connection. The pressure measured was found to be within the acceptable range of 40 to 80 pounds per square inch.

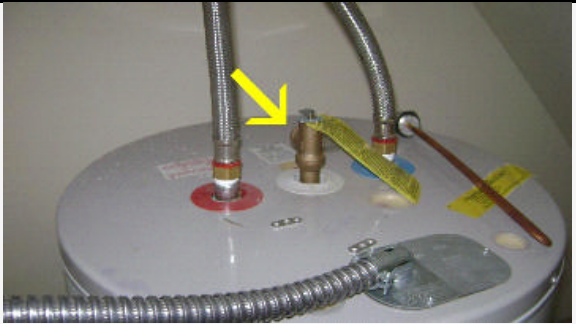
Water Heater Fill Valve Installed:	Yes - There is a fill valve installed on the incoming water line. This valve can be used to cut off the water supply to the water heater.
Temperature Controls:	The heating elements were not inspected due to their cover plates having to be removed. This is beyond the scope of the inspection.
Drain Valve:	Yes - There is a drain valve installed on the lower side of the water heater.
Temperature & Pressure Relief Valve:	Satisfactory - The temperature and pressure relief valve is of the correct rating for the water heater.
Safety Overflow Pipe:	<p>There is no overflow pipe installed on the TPR valve on the water heater. For safety reasons, immediate installation is needed to help minimize the possibility of serious injury. Pipe should be made out of copper or a plastic pipe that will withstand water temperatures over 200 degrees and be no further than 6" from the floor.</p>

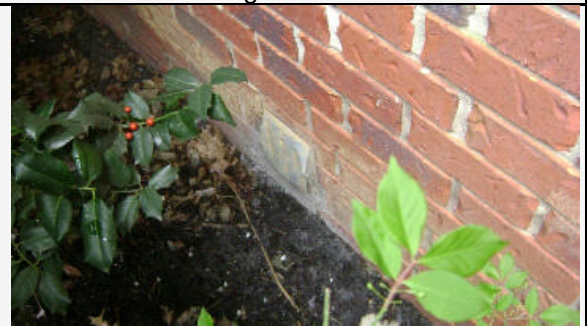
Dryer Ventilation:

The exterior dryer vent door is damaged and in poor condition and needs replaced. The inspector recommends replacing it with a 3 louvered type door made for this application which can be purchased at Lowes or Home Depot.

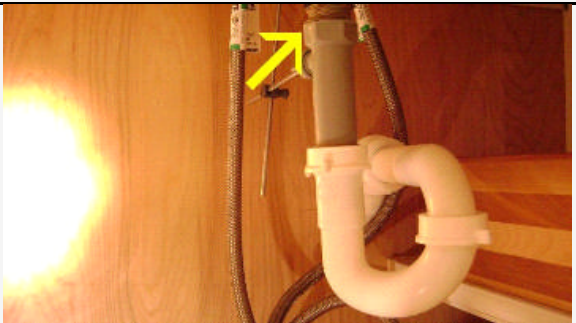
Lighting:	Satisfactory - The ceiling light and fixture in this bathroom appears to be in satisfactory condition.
Ventilation Fans:	There is an exhaust fan installed in this bathroom that appears to be functioning satisfactory.
Electrical Outlets:	The accessible GFCI (Ground Fault Circuit Interrupt) outlets (those not limited by current use or obstruction by possessions) were tested in the bathroom and appear to be functional and in satisfactory condition. Any electrical outlet within 6' of water should be GFCI protected.
Light Switch:	The light switch in this bathroom appears to be satisfactory.
Vanity Cabinet:	The vanity cabinet and countertop in this bathroom appear satisfactory.
Basin and Drain Fixture:	The basin and drainage fixture appears to be satisfactory.
Faucet and Supply Lines:	<p>The supply piping under the vanity shows signs of a leak and repairs are necessary. Services of a qualified licensed plumber are needed.</p>

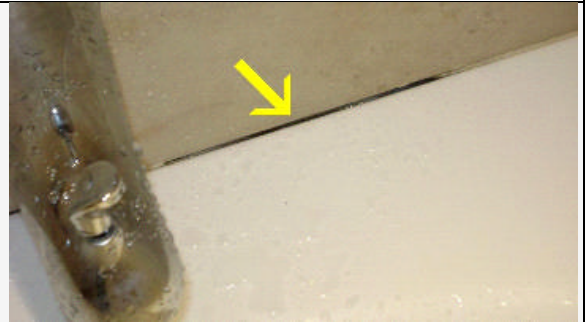
Tub & Shower Walls:

Missing grout was found between some of the tiles. There is no evidence of water damage yet. Do not delay making these repairs to prevent future damage. This area is behind the tub faucet.

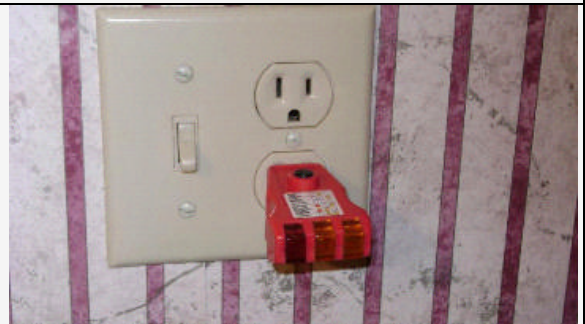
Electrical Outlets:

The accessible GFCI (Ground Fault Circuit Interrupt) outlets (those not limited by current use or obstruction by possessions) were tested in the bathroom and appear to be functional and in satisfactory condition. Any electrical outlet within 6' of water should be GFCI protected. However the outlet by the exterior door in this bathroom did not function at time of inspection.

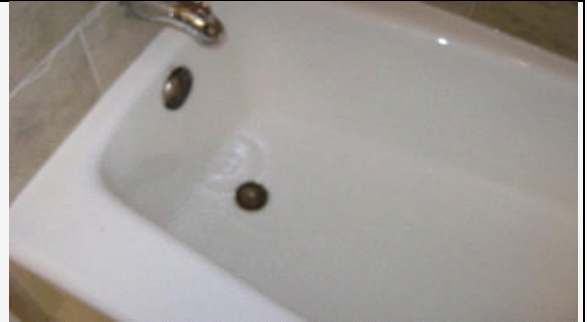
Tub/Shower Drain:

During the functional drain test, the tub/shower appears to drain slower than expected. Liquid Plumber may resolve the issue, however if it doesn't, a drain cleaning service company may be needed.

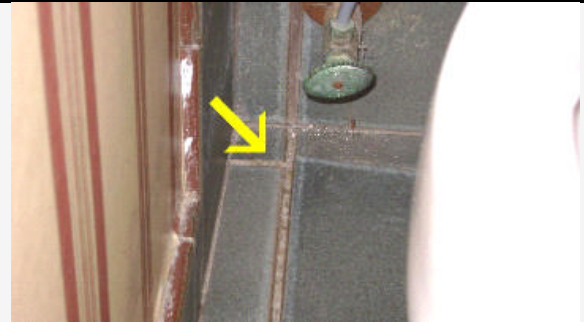
Floor Conditions:

One or more small hairline cracks were found in the bathroom floor. The floor appears to be sturdy in the area of the cracks however it was undetermined the cause. The crack is located to the right of the toilet. Also the tile on the floor at the left rear side of the toilet is not secure to the floor.

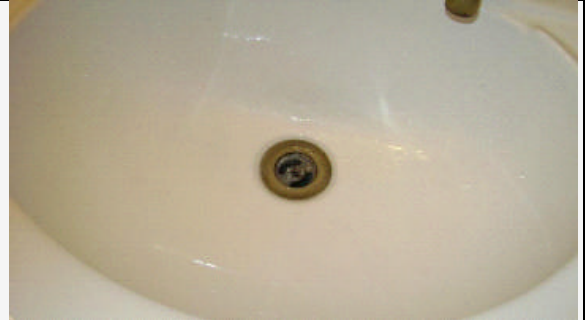
Basin and Drain Fixture:

The basin or drainage fixture needs attention. The drain fixture stopper is missing out of the sink therefore functional drain test was not performed. A drain stopper may be installed if needed.

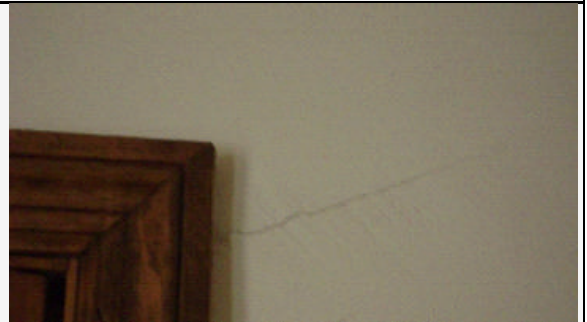
Walls:

One or more minor cracks were found in the walls of this bedroom. They do not appear to be a structural concern at this time but should be monitored for future movement. Most cracks over windows and doors are due to shrinkage in the building material or slight settlement. These type issues are subjective in nature and generally do not affect the durability and serviceability of the components of the building. This is over the bathroom doorway.

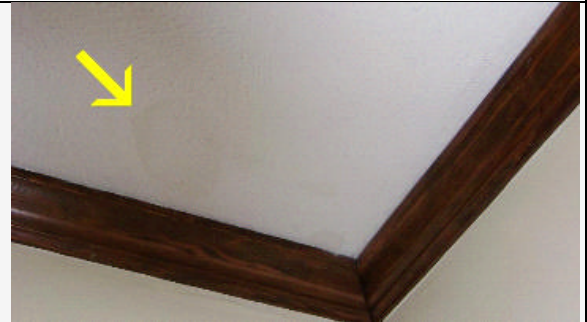
Ceiling:

Leak stains were found in the ceiling of this room that appear to have come from some type of roof leak. Action is necessary to determine if the roof has been successfully repaired or if the leak is still active.

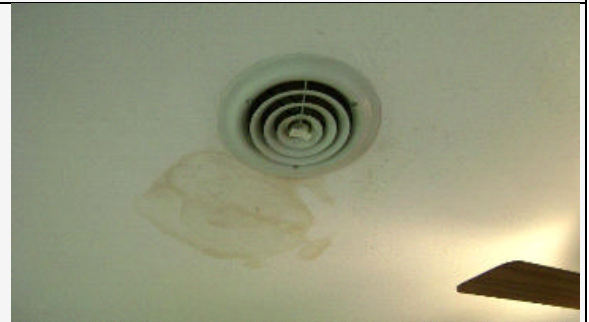
Leak stains were found in the ceiling of this room that appear to have come from some type of roof leak. Action is necessary to determine if the roof has been successfully repaired or if the leak is still active.

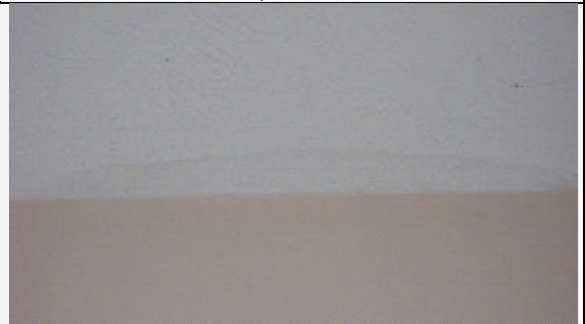
Ceiling:

Leak stains were found on the ceiling of this room. Due to the condition of the roof and no active leaks in the attic, these stains are believed to be from a prior leak. The stains should be painted and the area monitored for any future leakage. This is located in the small hallway by the laundry room.

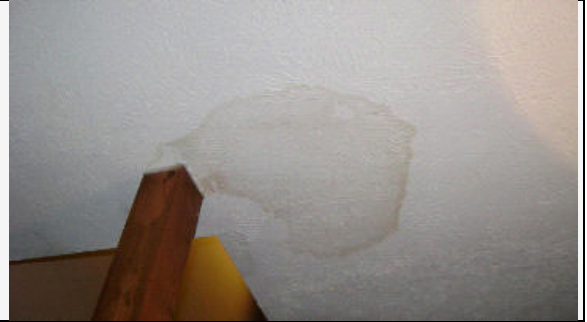
Upper Level Hallway:

A leak stain was found on the upstairs hallway ceiling. This is believed to have come from the ac unit above this area in the attic. This is also mentioned in the heating section above. Repairs to the ceiling are needed.

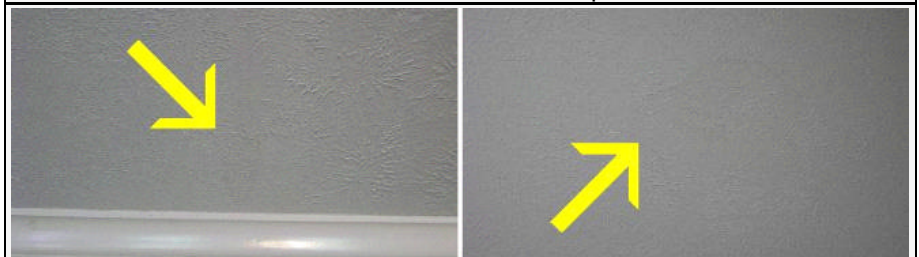
Ceiling:

Several leak stains were found on the ceiling of this room which is below one of the upstairs bathrooms. No elevated moisture levels were measured in the area of the stains however they should be monitored when the bathroom is in use and the necessary repairs made if the leak becomes active.

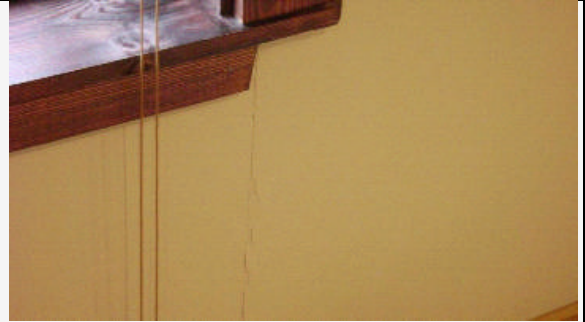
Walls:

One or more minor cracks were found in the walls of this room. They do not appear to be a structural concern at this time but should be monitored for future movement. Most cracks over windows and doors are due to shrinkage in the building material or slight settlement. These type issues are subjective in nature and generally do not affect the durability and serviceability of the components of the building. Located under the far right window.

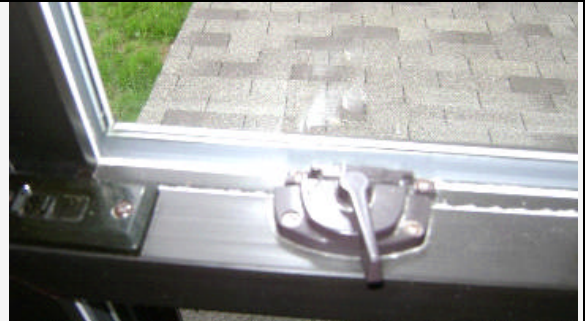
Windows:

The locking hardware on the far left window is either broken, missing, or will not properly align to lock the window and repairs are needed.

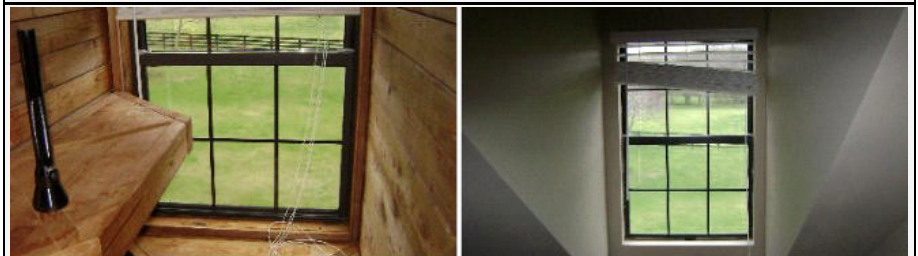
Windows:

Two windows in the front side of this room needs repair or replacement. The thermal seal between the two panes of glass appear broken. Although the window is keeping the elements out, it has a clouded or wet like appearance. This condition will worsen and the panes will eventually need replaced. (2) The assist spring or window track that supports the window in the up position is not functional. Repairs are needed.

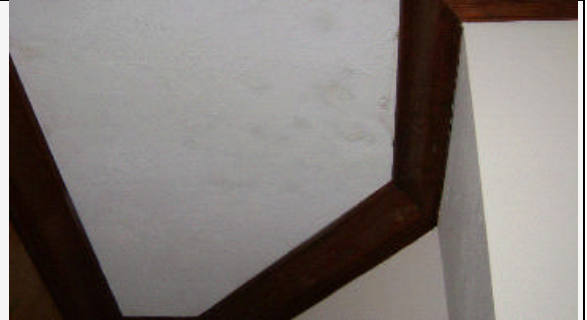
Ceiling:

Leak stains were found on the ceiling around the fireplace in this room. This is covered in the roof section above in the report.

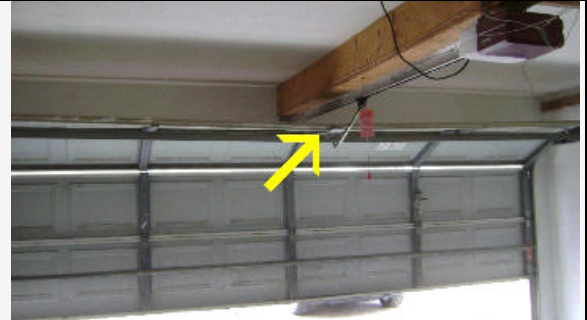
Overhead Door and Hardware Condition:

The upper garage door panel is broken causing it to significantly sag when in the open position and appears unstable when the door opener is being used. The panel will either need properly braced or replaced to function as designed.

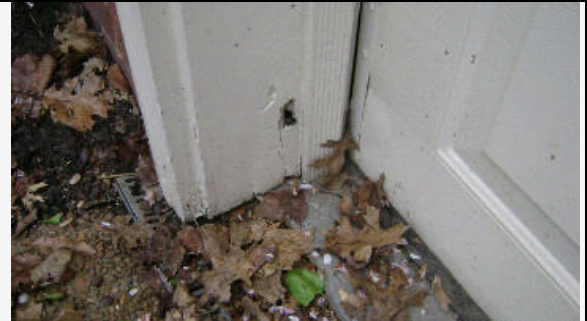
Garage Door Jam

The lower garage door jamb has started to deteriorate and will soon need replaced. The inspector recommends replacing the jamb with pressure treated pine lumber.

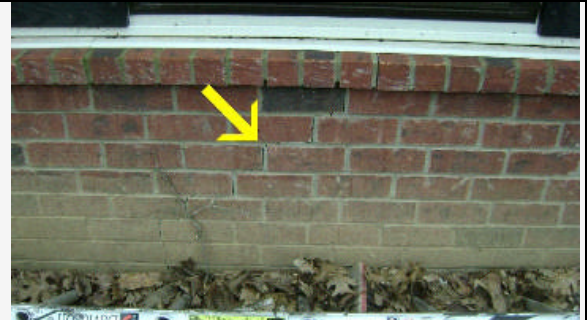
Garage Foundation:

A crack was found in the detached garage foundation on the right end of the building. This will need inspected as well along with the main structure foundation issues.

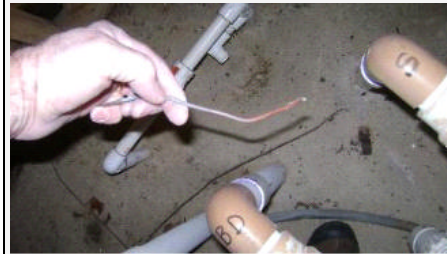
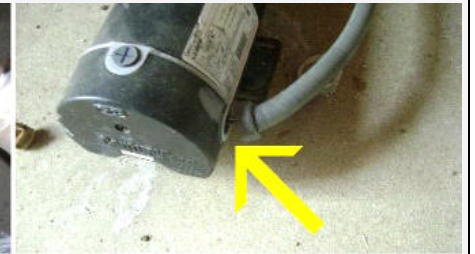
Electrical Service to Equipment:

The electrical bonding ground wire was found disconnected from the filter pump motor. This is considered unsafe and immediate action is required to have it properly reconnected. (2) The electrical conduit connector is broken at the pump motor and needs replaced. These issues should be corrected by a qualified license electrician.
